# Fiberglass Shingles

## *Shingle Splitting Problem Observed in a Number of Western Applications*

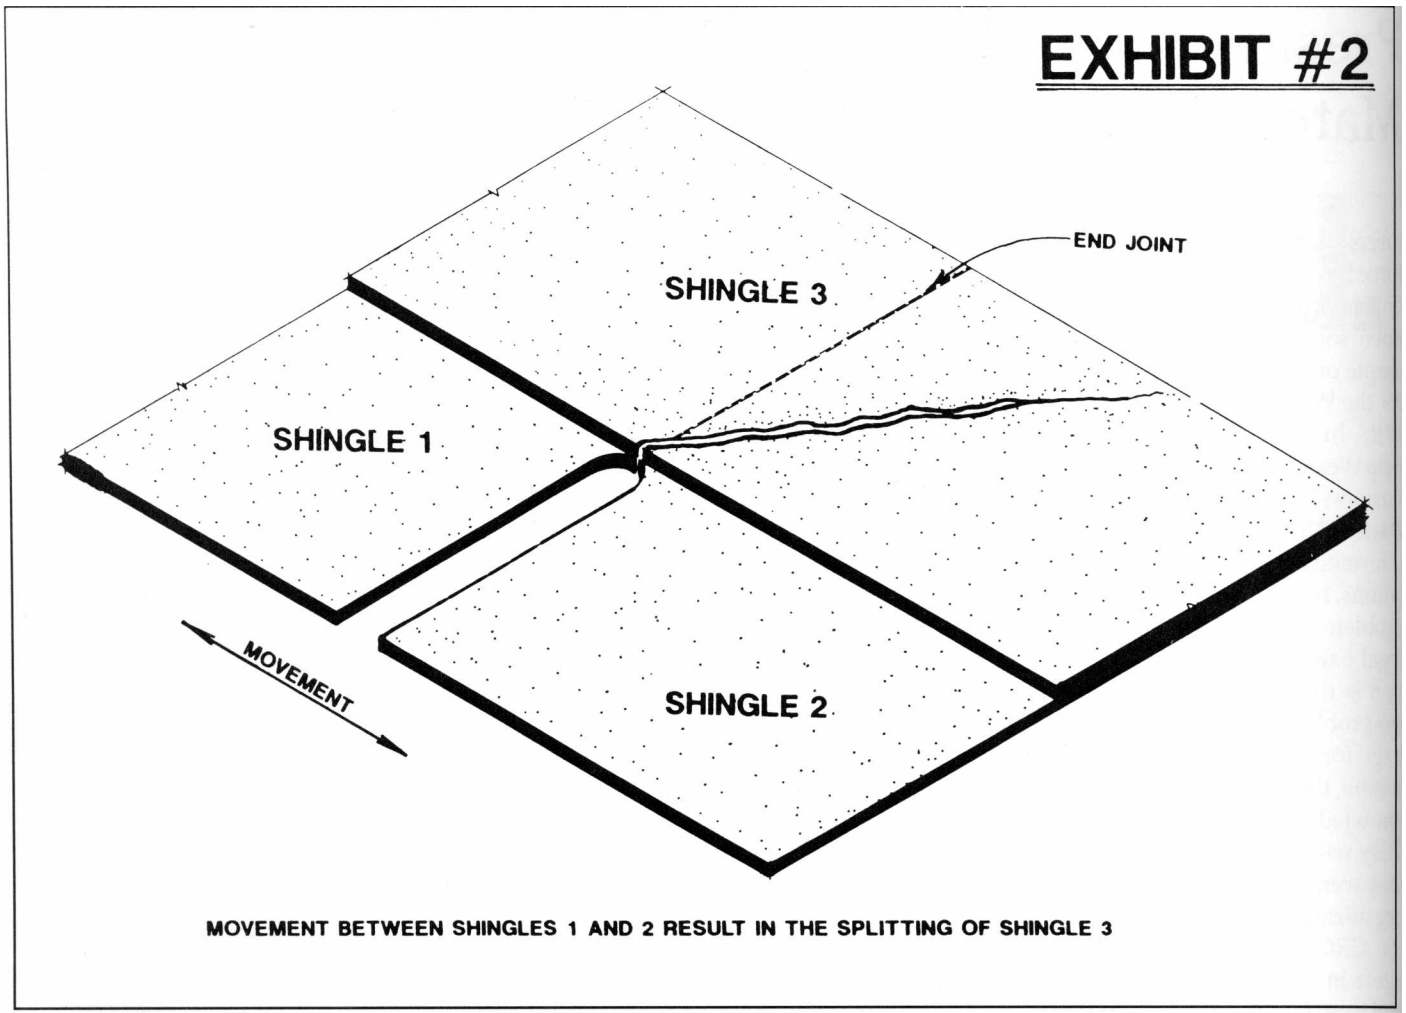
## EXHIBIT #2

D 3018, Type I, and generally carry a UL Class A rating. These shingles have been splitting in the face of the shingle directly above the edge joint of the preceding shingle. The splitting problem in the fiberglass shingle appears to be independent of either substrate or fastener type.

The fiberglass shingles have a tendency to expand and contract with thermal changes along the longitudinal basis. As the shingle expands and contracts, a stress builds up in the face of the shingle directly over the end joints of the underlying shingle. This produces a split in the face of the three-tab shingle.

In examining many of these shingles, it has been observed that the splitting action begins predominantly in the southward and westward exposures of the building. If one examines these structures in the early morning hours when the roof is cool, these splits are very obvious, and tend to run in a diagonal fashion. As the roof warms

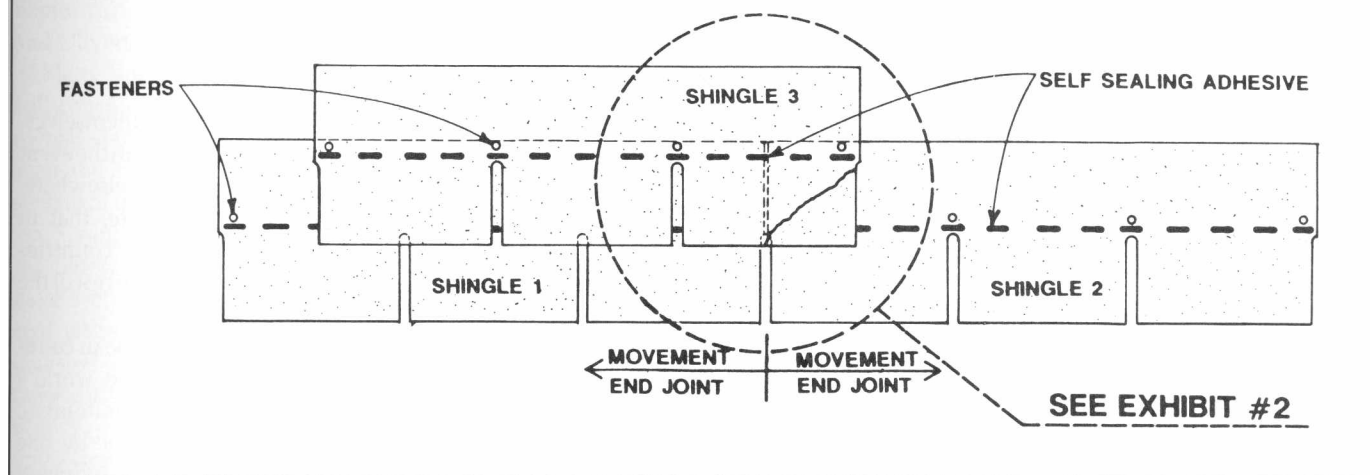
# EXHIBIT #1

The failure mode is a combination of three factors: a lack of sufficient tensile strength in the fiberglass mat; thermal expansion and contraction of the shingles; and a full adhesion of the self-sealer strip over the end joints. From a tensile strength standpoint, it has been observed that in some cases, when an individual shingle is picked up and held vertically, it will tear under its own weight. In performing a tensile strength test, it

has been observed that shingles with the greatest tear tendency have a tensile strength below 60 pounds per inch at the time of failure.

At the present time, the bulk of these shingles fall under ASTM D 3018-79 Type 1. There is not a clear-cut industry standard for tensile strength or the quantity or spacing of self-sealer adhesive. Areas such as a minimum tensile strength, adhesive spacing, and quantity should be addressed by the industry.
