Aging and Hail Research of PVC Membranes

Frank J. Foley, Jim D. Koontz and Joseph K. Valaitis

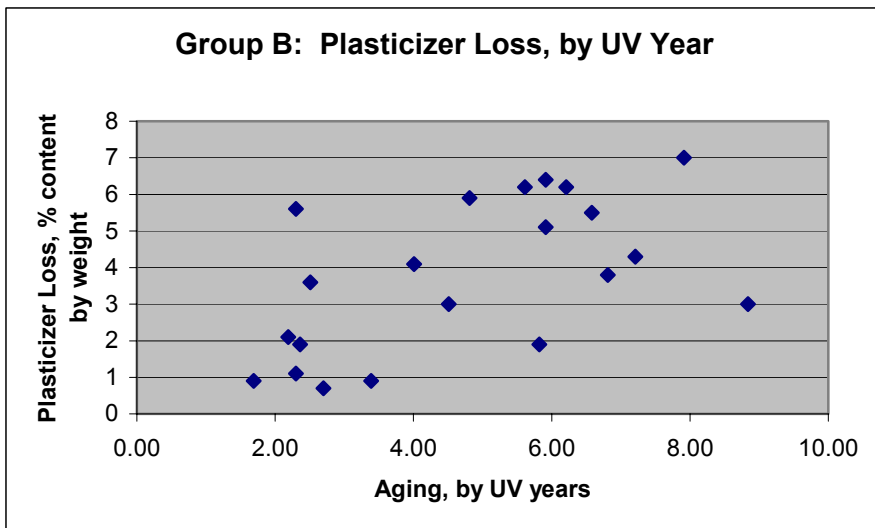
Graph 1: Group B plasticizer loss by UV year

The relationship between aging and plasticizer loss by UV year for both groups B and D is provided in *Graphs 1 and 2*.

A glance of the graphs provides two quick observations. The cluster of data for group D is much tighter than group B. This visual observation is consistent with Pearson Correlation Analysis in *Table 8*. Furthermore, plasticizer loss in the samples in group D does not actually begin until the sixth year. At least at the outset, group D plasticizer ingredients appear to be vastly more stable in the membrane to those in group B. The visual comparison of the scatter patterns of the two graphs also reveal that group D
