"Field Evaluation and Laboratory Testing of PVC Roofing Systems"

Jim D. Koontz, P.E.

1997 International Symposium on
Roofing Technology

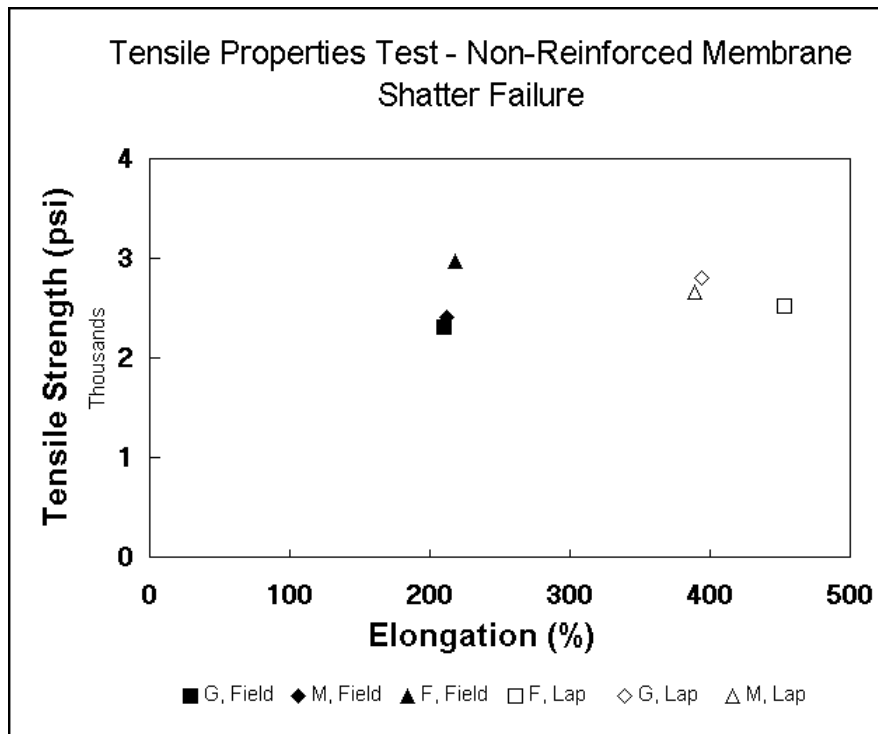
Many PVC manufacturers list tensile strength and elongation characteristics in their marketing literature. As a PVC membrane ages and experiences a loss of plasticizer, these properties change. Generally, there tends to be a decrease in the elongation rate as plasticizer decreases. In some circumstances there may even be an increase in the tensile strength as the product ages. Figure 4 shows the tensile/elongation strength characteristics for exposed membrane versus non-exposed portions of the lap for three (3) different projects where a shatter failure had occurred with non-reinforced products.

Figure 4, Tensile/Elongation Rates for Non-Reinforced Shattered Membranes.

The unexposed lap portions have elongation rates in the 400 percent range; whereas the field portion of these particular shatter failure samples have elongation rates of approximately 200 percent. There is clearly a substantial difference between the properties of the unexposed, unbonded lap and the field. If one observes the same type of numbers in Figure 6 for non-reinforced impact/hail failures, the same type of trend occurs; however, the elongation rate for the failed field samples range between 200 percent and 300 percent.

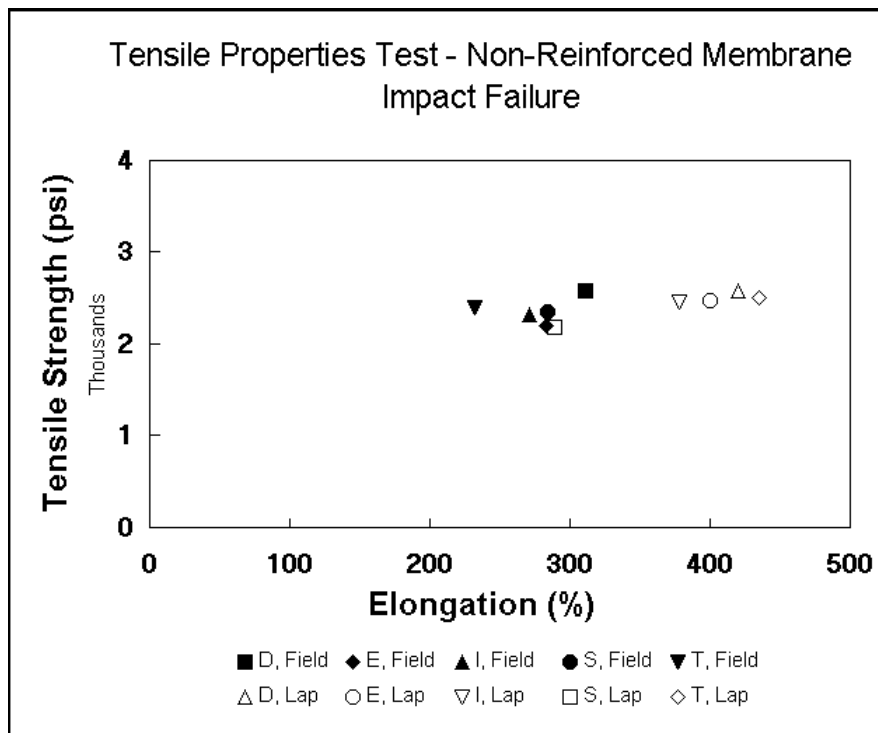
Figure 6, Tensile/Elongation None-Reinforced Membrane Impact Failure.

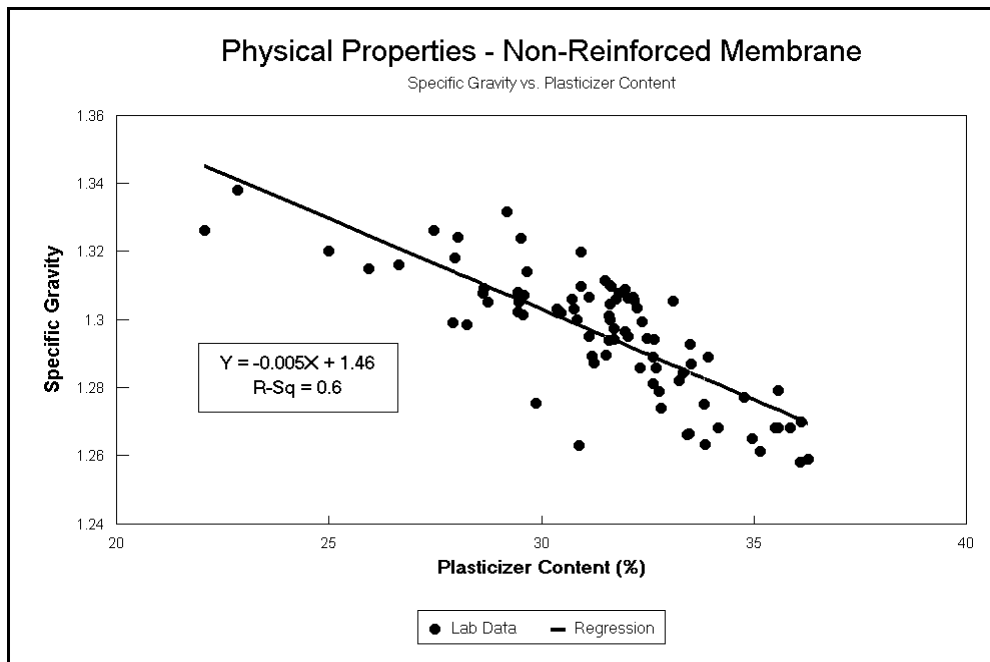
A comparison between the plasticizer content and specific gravity of various samples is shown in Figure 12. In performing a regression analysis, one sees the correlation between specific gravity of a membrane sheet and its plasticizer content. The plasticizer content test, ASTM D3421, has been discontinued and is somewhat more difficult to run than a specific gravity test.

Figure 12, Specific Gravity/Plasticizer Content Comparison.
